## **ASBESTOS RE-INSPECTION SURVEY REPORT**

**Flats 1-6 Nouncells Cross  
Bisley Old Road  
Stroud  
Gloucestershire  
GL5 1PT**

**30th September 2024**

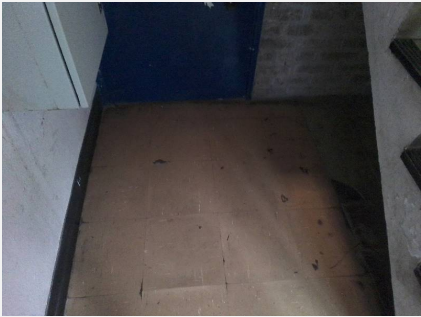
1	ET000971*	Ground Floor	Main building Circulation and Stairs 001				3 m²	
ID	Material Description		Product Type				Asbestos Type	
AD	Orange floor tiles and adhesive to concrete		Vinyl Floor Tiles & Bitumen Products				Chrysotile	
Accessibility	Product Type	Extent of Damage	Surface Treatment	Asbestos Type	Total	Priority	Recommendation	Comments
Routinely disturbed	1	1	0	1	3	Low	Monitor Condition	Includes half landing. Reinspected on 30th September 2024, no change in condition.

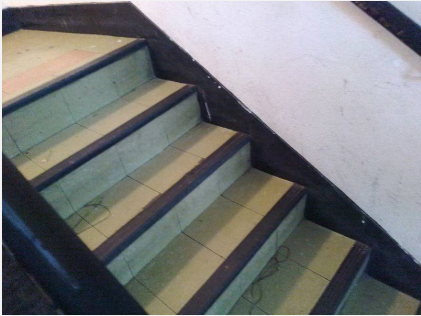
2	ET000972*	Ground Floor	Main building Circulation and Stairs 001				4 m²	
ID	Material Description		Product Type				Asbestos Type	
AD	Green floor tiles and adhesive to concrete		Vinyl Floor Tiles & Bitumen Products				Chrysotile	
Accessibility	Product Type	Extent of Damage	Surface Treatment	Asbestos Type	Total	Priority	Recommendation	Comments
Routinely disturbed	1	1	0	1	3	Low	Monitor Condition	Reinspected on 30th September 2024, no change in condition.

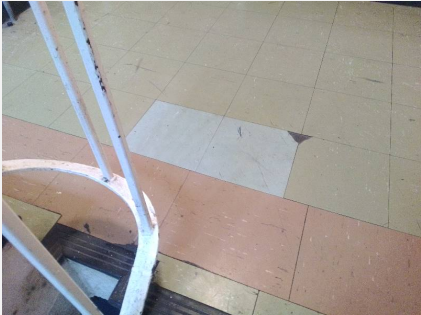
3	ET000973*	Ground Floor	Main building Circulation and Stairs 001				2 no.	
ID	Material Description		Product Type				Asbestos Type	
AD	Blue floor tiles and adhesive to concrete		Vinyl Floor Tiles & Bitumen Products				Chrysotile	
Accessibility	Product Type	Extent of Damage	Surface Treatment	Asbestos Type	Total	Priority	Recommendation	Comments
Routinely disturbed	1	1	0	1	3	Low	Monitor Condition	Asbestos detected in adhesive only. Reinspected on 30th September 2024, no change in condition.

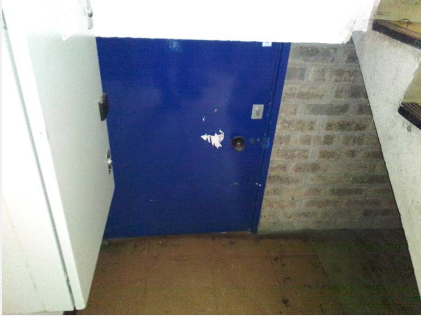
4	No sample taken	Ground Floor	Main building Circulation and Stairs 001				Throughout	
ID	Material Description		Product Type				Asbestos Type	
PTCA	No access gained to cupboard due to no key available at the time of the survey		N/A				Presumed	
Accessibility	Product Type	Extent of Damage	Surface Treatment	Asbestos Type	Total	Priority	Recommendation	Comments
N/A	N/A	N/A	N/A	N/A	N/A	N/A	Exercise Caution	Presumed chrysotile. Reinspected on 30th September 2024, no change in condition.

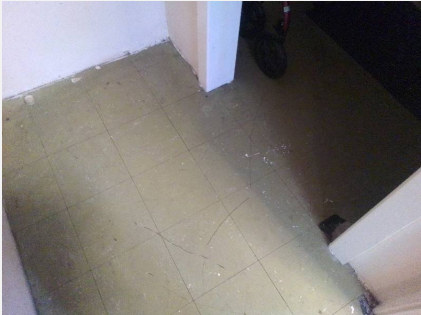
5	As ET000972*	Ground Floor	Main building Circulation 002				2 m²	
ID	Material Description		Product Type				Asbestos Type	
SPTCA	Green floor tiles and adhesive to concrete		Vinyl Floor Tiles & Bitumen Products				Chrysotile	
Accessibility	Product Type	Extent of Damage	Surface Treatment	Asbestos Type	Total	Priority	Recommendation	Comments
Routinely disturbed	1	1	0	1	3	Low	Monitor Condition	Reinspected on 30th September 2024, no change in condition.

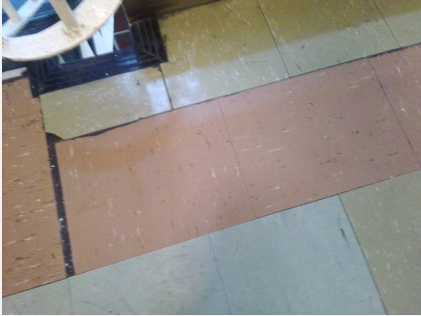
6	ET000974*	1st Floor	Main building Landing and Stairs 101				1 m²	
ID	Material Description		Product Type				Asbestos Type	
AD	Orange floor tiles and adhesive to concrete		Vinyl Floor Tiles & Bitumen Products				Chrysotile	
Accessibility	Product Type	Extent of Damage	Surface Treatment	Asbestos Type	Total	Priority	Recommendation	Comments
Routinely disturbed	1	1	0	1	3	Low	Monitor Condition	Asbestos detected in adhesive only. Reinspected on 30th September 2024, no change in condition.

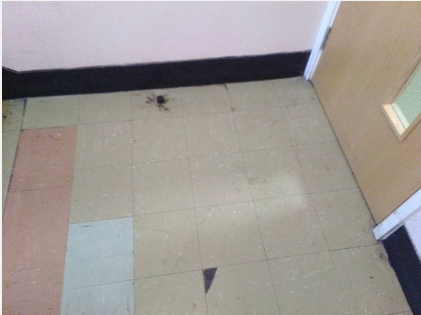
7	ET000975*	1st Floor	Main building Landing and Stairs 101				6 m²	
ID	Material Description		Product Type				Asbestos Type	
AD	Green floor tiles and adhesive to concrete		Vinyl Floor Tiles & Bitumen Products				Chrysotile	
Accessibility	Product Type	Extent of Damage	Surface Treatment	Asbestos Type	Total	Priority	Recommendation	Comments
Routinely disturbed	1	1	0	1	3	Low	Monitor Condition	Reinspected on 30th September 2024, no change in condition.

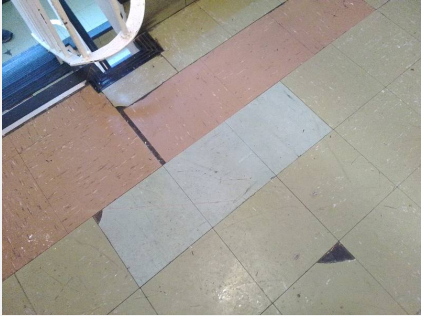
8	ET000976*	1st Floor	Main building Landing and Stairs 101				3 no.	
ID	Material Description		Product Type				Asbestos Type	
AD	Blue floor tiles and adhesive to concrete		Vinyl Floor Tiles & Bitumen Products				Chrysotile	
Accessibility	Product Type	Extent of Damage	Surface Treatment	Asbestos Type	Total	Priority	Recommendation	Comments
Routinely disturbed	1	1	0	1	3	Low	Monitor Condition	Asbestos detected in adhesive only. Reinspected on 30th September 2024, no change in condition.

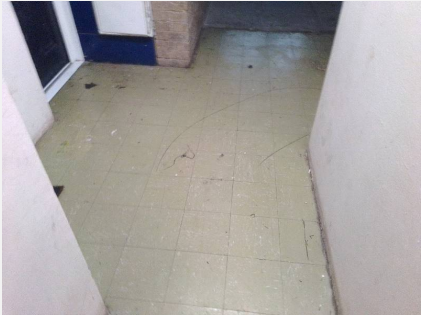
9	As ET000975*	1st Floor	Main building Circulation 102				6 m²	
ID	Material Description		Product Type				Asbestos Type	
SPTCA	Green floor tiles and adhesive to concrete		Vinyl Floor Tiles & Bitumen Products				Chrysotile	
Accessibility	Product Type	Extent of Damage	Surface Treatment	Asbestos Type	Total	Priority	Recommendation	Comments
Routinely disturbed	1	1	0	1	3	Low	Monitor Condition	Reinspected on 30th September 2024, no change in condition.

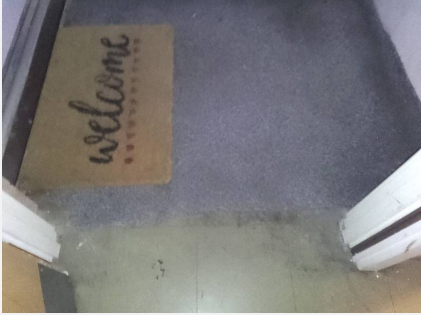
10	As ET000975*	1st Floor	Main building Circulation 103				1 m²	
ID	Material Description		Product Type				Asbestos Type	
SPTCA	Green floor tiles and adhesive to concrete		Vinyl Floor Tiles & Bitumen Products				Chrysotile	
Accessibility	Product Type	Extent of Damage	Surface Treatment	Asbestos Type	Total	Priority	Recommendation	Comments
Routinely disturbed	1	1	0	1	3	Low	Monitor Condition	Reinspected on 30th September 2024, no change in condition.

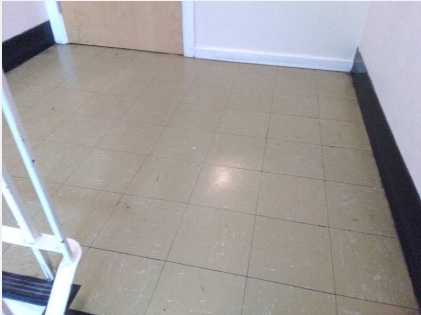
11	ET000977*	2nd Floor	Main building Landing and Stairs 201				8 m²	
ID	Material Description		Product Type				Asbestos Type	
AD	Green floor tiles and adhesive to concrete		Vinyl Floor Tiles & Bitumen Products				Chrysotile	
Accessibility	Product Type	Extent of Damage	Surface Treatment	Asbestos Type	Total	Priority	Recommendation	Comments
Routinely disturbed	1	1	0	1	3	Low	Monitor Condition	Reinspected on 30th September 2024, no change in condition.

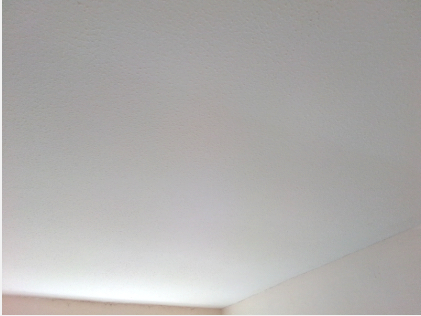
12	ET000978*	2nd Floor	Main building Landing and Stairs 201				8 m²	
ID	Material Description		Product Type				Asbestos Type	
AD	Textured coating to Plasterboard ceiling		Textured Coating				Chrysotile	
Accessibility	Product Type	Extent of Damage	Surface Treatment	Asbestos Type	Total	Priority	Recommendation	Comments
Usually inaccessible or unlikely to be disturbed	1	1	0	1	3	Low	Monitor Condition	Reinspected on 30th September 2024, no change in condition.

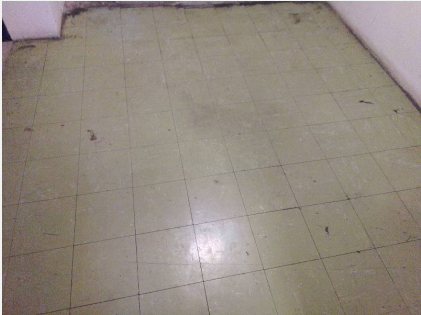
13	As ET000977*	2nd Floor	Main building Circulation 202				6 m²	
ID	Material Description		Product Type				Asbestos Type	
SPTCA	Green floor tiles and adhesive to concrete		Vinyl Floor Tiles & Bitumen Products				Chrysotile	
Accessibility	Product Type	Extent of Damage	Surface Treatment	Asbestos Type	Total	Priority	Recommendation	Comments
Routinely disturbed	1	1	0	1	3	Low	Monitor Condition	Reinspected on 30th September 2024, no change in condition.

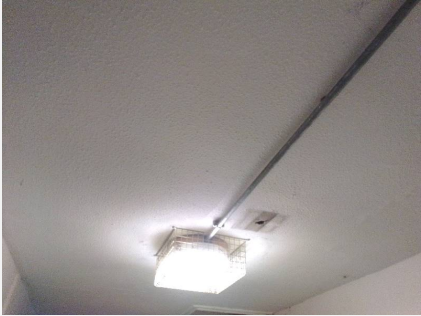
14	As ET000978*	2nd Floor	Main building Circulation 202				12 m²	
ID	Material Description		Product Type				Asbestos Type	
SPTCA	Textured coating to Plasterboard ceiling		Textured Coating				Chrysotile	
Accessibility	Product Type	Extent of Damage	Surface Treatment	Asbestos Type	Total	Priority	Recommendation	Comments
Usually inaccessible or unlikely to be disturbed	1	1	0	1	3	Low	Monitor Condition	Reinspected on 30th September 2024, no change in condition.

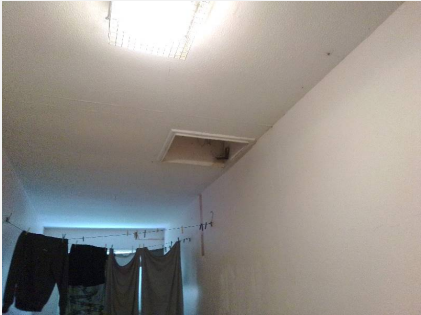
15	No sample taken	2nd Floor	Main building Circulation 202				Throughout	
ID	Material Description		Product Type				Asbestos Type	
PTCA	No access gained to hatch due to no key available at the time of the survey		N/A				Presumed	
Accessibility	Product Type	Extent of Damage	Surface Treatment	Asbestos Type	Total	Priority	Recommendation	Comments
N/A	N/A	N/A	N/A	N/A	N/A	N/A	Exercise Caution	Presumed chrysotile. Reinspected on 30th September 2024, no change in condition.

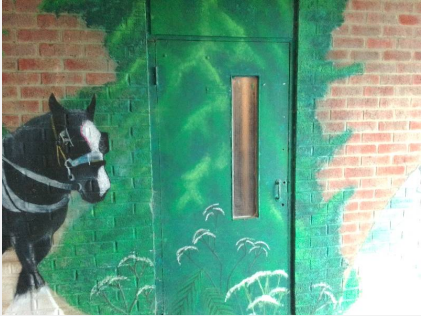
16	No sample taken	Ground Floor	Main building Cupboard 003				Throughout	
ID	Material Description		Product Type				Asbestos Type	
PTCA	No access gained to cupboard due to no key available at the time of the survey		N/A				Presumed	
Accessibility	Product Type	Extent of Damage	Surface Treatment	Asbestos Type	Total	Priority	Recommendation	Comments
N/A	N/A	N/A	N/A	N/A	N/A	N/A	Exercise Caution	Presumed chrysotile. Reinspected on 30th September 2024, no change in condition.

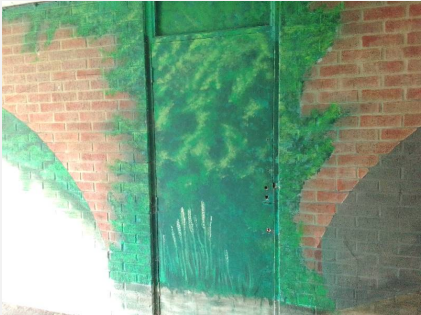
17	No sample taken	Ground Floor	Main building Cupboard 004				Throughout	
ID	Material Description		Product Type				Asbestos Type	
PTCA	No access gained to cupboard due to no key available at the time of the survey		N/A				Presumed	
Accessibility	Product Type	Extent of Damage	Surface Treatment	Asbestos Type	Total	Priority	Recommendation	Comments
N/A	N/A	N/A	N/A	N/A	N/A	N/A	Exercise Caution	Presumed chrysotile. Reinspected on 30th September 2024, no change in condition.

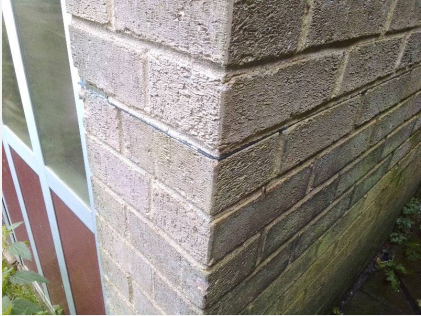
18	ET000979*	External	Main building External Areas E01				Throughout	
ID	Material Description		Product Type				Asbestos Type	
AD	Damp proof membrane		Bitumen Products				Chrysotile	
Accessibility	Product Type	Extent of Damage	Surface Treatment	Asbestos Type	Total	Priority	Recommendation	Comments
Usually inaccessible or unlikely to be disturbed	1	1	0	1	3	Low	Monitor Condition	Reinspected on 30th September 2024, no change in condition.

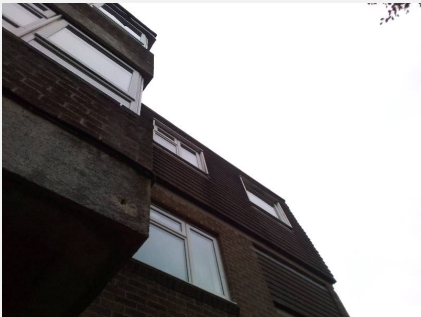
19	No sample taken	External	Main building External Areas E01				Throughout	
ID	Material Description		Product Type				Asbestos Type	
PTCA	No access gained to soffits due to height restrictions		N/A				Presumed	
Accessibility	Product Type	Extent of Damage	Surface Treatment	Asbestos Type	Total	Priority	Recommendation	Comments
N/A	N/A	N/A	N/A	N/A	N/A	N/A	Exercise Caution	Presumed chrysotile. Reinspected on 30th September 2024, no change in condition.

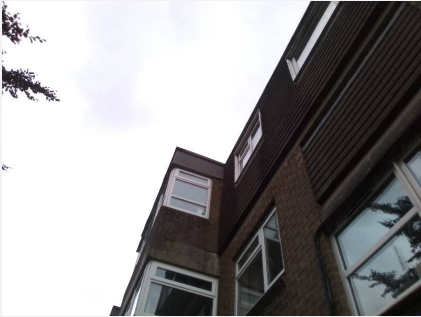
20	No sample taken	External	Main building External Areas E01				Throughout	
ID	Material Description		Product Type				Asbestos Type	
PTCA	No access gained to high level roof due to height restrictions		N/A				Presumed	
Accessibility	Product Type	Extent of Damage	Surface Treatment	Asbestos Type	Total	Priority	Recommendation	Comments
N/A	N/A	N/A	N/A	N/A	N/A	N/A	Exercise Caution	Presumed chrysotile. Reinspected on 30th September 2024, no change in condition.
