ASBESTOS REFURBISHMENT SURVEY REPORT

**Jenner Court
Berkeley
Gloucestershire
GL13 9BT**

20th May 2021

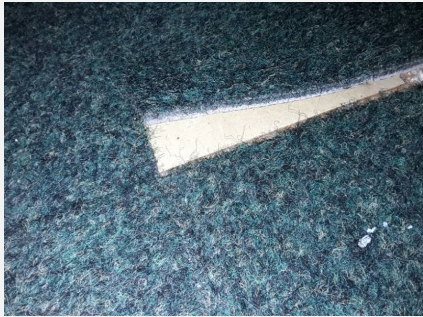
1	LY000676	Ground Floor	Main Building Lounge 001				15 m ²	
ID	Material Description		Product Type			Asbestos Type		
AD	Cream vinyl tiles under carpet		Vinyl Floor Tiles			Chrysotile		
Accessibility	Product Type	Extent of Damage	Surface Treatment	Asbestos Type	Total	Priority	Recommendation	Comments
Occasionally likely to be disturbed	1	1	0	1	3	Low	Remove if affected by proposed refurbishment works

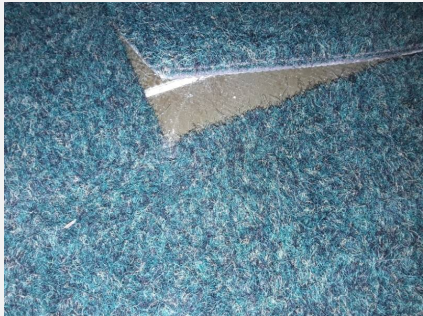
2	LY000677	Ground Floor	Main Building Lounge 001				15 m ²	
ID	Material Description		Product Type			Asbestos Type		
AD	Green vinyl tiles under carpet		Vinyl Floor Tiles			Chrysotile		
Accessibility	Product Type	Extent of Damage	Surface Treatment	Asbestos Type	Total	Priority	Recommendation	Comments
Occasionally likely to be disturbed	1	1	0	1	3	Low	Remove if affected by proposed refurbishment works

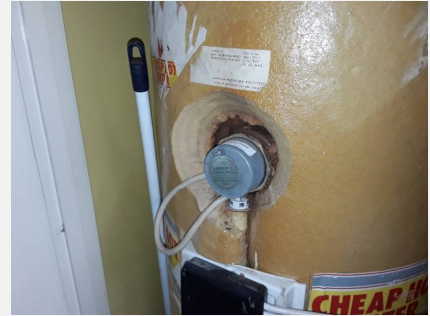
4	No sample taken	Ground Floor	Main Building Laundry 003				2 no.	
ID	Material Description		Product Type				Asbestos Type	
PTCA	No access to inspect gaskets due to live status		N/A				Presumed	
Accessibility	Product Type	Extent of Damage	Surface Treatment	Asbestos Type	Total	Priority	Recommendation	Comments
N/A	N/A	N/A	N/A	N/A	N/A	N/A	Exercise Caution	Presumed chrysotile.

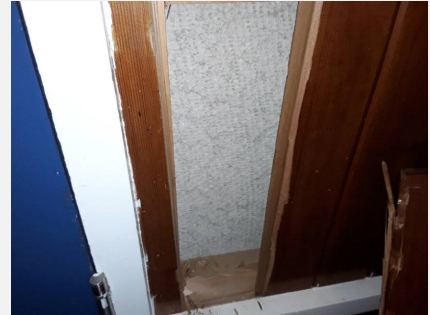
8	LY000682	Ground Floor	Main Building Entrance lobby and cupboard 008				2 m ²	
ID	Material Description		Product Type				Asbestos Type	
AD	Insulating board panel within timber partition between lounge and entrance lobby		Asbestos Insulating Board				Chrysotile	
Accessibility	Product Type	Extent of Damage	Surface Treatment	Asbestos Type	Total	Priority	Recommendation	Comments
Easily disturbed	2	1	2	1	6	Low	Remove if affected by proposed refurbishment works

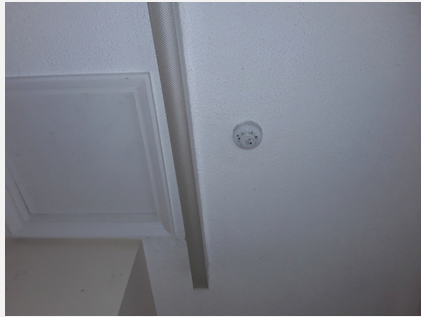
3	LY000678	Ground Floor	Main Building Kitchen 002				15 m ²	
ID	Material Description		Product Type				Asbestos Type	
NAD	Textured coating to ceiling		N/A				No Asbestos Detected	
Accessibility	Product Type	Extent of Damage	Surface Treatment	Asbestos Type	Total	Priority	Recommendation	Comments
N/A	N/A	N/A	N/A	N/A	N/A	N/A	No Action	Continues into cupboard

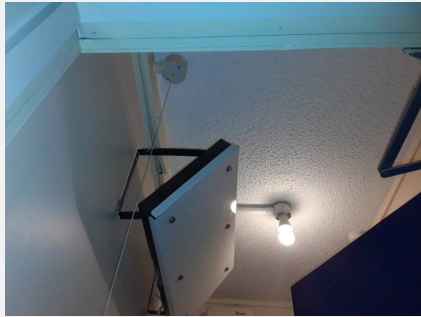
5	LY000679	Ground Floor	Main Building Toilet 005				2 m ²	
ID	Material Description		Product Type				Asbestos Type	
NAD	Textured coating to concrete ceiling		N/A				No Asbestos Detected	
Accessibility	Product Type	Extent of Damage	Surface Treatment	Asbestos Type	Total	Priority	Recommendation	Comments
N/A	N/A	N/A	N/A	N/A	N/A	N/A	No Action

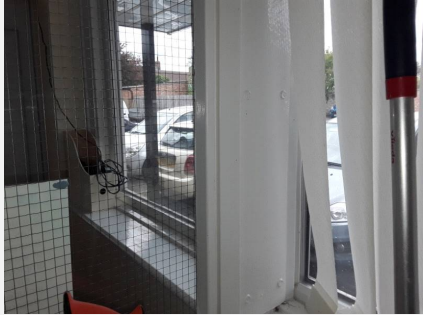
6	LY000680	Ground Floor	Main Building Office 007				1 no.	
ID	Material Description		Product Type				Asbestos Type	
NAD	Insulating board to window reveal		N/A				No Asbestos Detected	
Accessibility	Product Type	Extent of Damage	Surface Treatment	Asbestos Type	Total	Priority	Recommendation	Comments
N/A	N/A	N/A	N/A	N/A	N/A	N/A	No Action

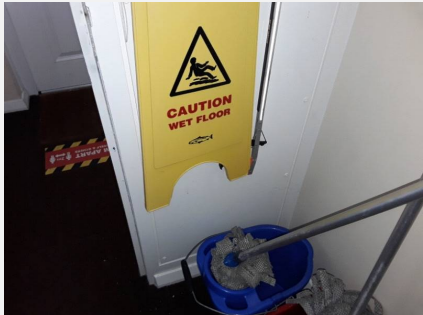
7	LY000681	Ground Floor	Main Building Office 007				2 no.	
ID	Material Description		Product Type				Asbestos Type	
NAD	Insulating board panel to side of door		N/A				No Asbestos Detected	
Accessibility	Product Type	Extent of Damage	Surface Treatment	Asbestos Type	Total	Priority	Recommendation	Comments
N/A	N/A	N/A	N/A	N/A	N/A	N/A	No Action

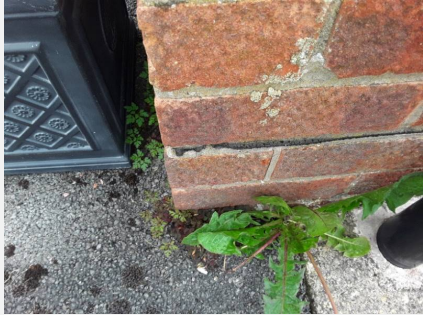
9	LY000683	External	Main Building External E01				10 lm	
ID	Material Description		Product Type				Asbestos Type	
NAD	Damp proof membrane to base of wall		N/A				No Asbestos Detected	
Accessibility	Product Type	Extent of Damage	Surface Treatment	Asbestos Type	Total	Priority	Recommendation	Comments
N/A	N/A	N/A	N/A	N/A	N/A	N/A	No Action
