ASBESTOS REFURBISHMENT SURVEY REPORT

**St Nicholas Court Opu
Elmgrove Estate
Hardwicke
Gloucester
Gloucestershire
GL2 4XW**

4th January 2024

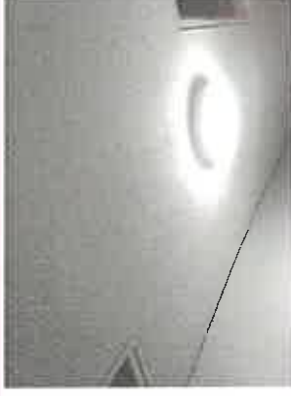
Incident Reference	Sample Number	Level	Material Location	Quantity
15	EI002180	Ground Floor	Main Building Circulation - Flats 28-35 001	11 m ²
ID	Material Description	Product Type	Asbestos Type	
AD	Textured coating to plasterboard ceiling	Textured Coating	Chrysotile	
Accessibility	Product Type	Extent of Damage	Surface Treatment	Asbestos Type
Usually inaccessible or unlikely to be disturbed	1	1	0	1
				Priority
				Low
				Recommendation
				Remove if affected by proposed refurbishment works

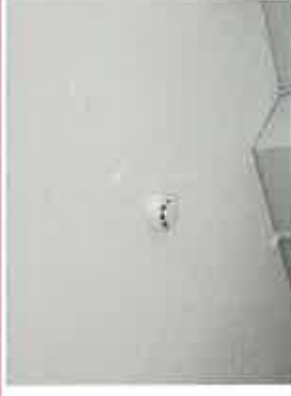
Incident Reference	Sample Number	Level	Material Location	Quantity
17	As EI002180	Ground Floor	Main Building Circulation - Flats 23-27 003	8 m ²
ID	Material Description	Product Type	Asbestos Type	
SPTCA	Textured coating to plasterboard ceiling	Textured Coating	Chrysotile	
Accessibility	Product Type	Extent of Damage	Surface Treatment	Asbestos Type
Usually inaccessible or unlikely to be disturbed	1	1	0	1
				Priority
				Low
				Recommendation
				Remove if affected by proposed refurbishment works

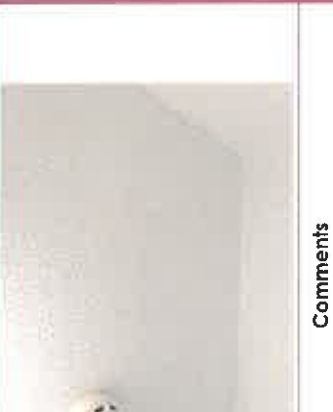
Incident Reference	Sample Number	Level	Material Location	Quantity	
21	As EI002180	Ground Floor	Main Building Office Lobby 004	1.5 m ²

ID	Material Description	Product Type	Asbestos Type		
SPICA	Textured coating to plasterboard ceiling	Textured Coating	Chrysotile		
Accessibility	Product Type	Extent of Damage	Surface Treatment	Asbestos Type	Recommendation
Usually inaccessible or unlikely to be disturbed	1	1	0	1	Remove if affected by proposed refurbishment works
				Total	Priority
				3	Low

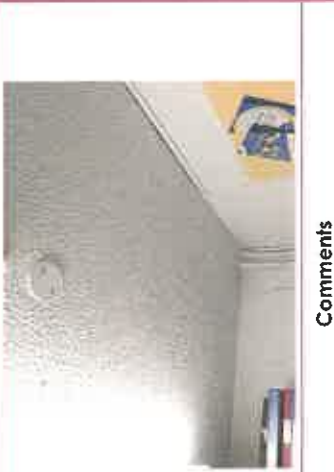
Incident Reference	Sample Number	Level	Material Location	Quantity	
22	As EI002180	Ground Floor	Main Building Office 005	4 m ²

ID	Material Description	Product Type	Asbestos Type		
SPICA	Textured coating to plasterboard ceiling	Textured Coating	Chrysotile		
Accessibility	Product Type	Extent of Damage	Surface Treatment	Asbestos Type	Recommendation
Usually inaccessible or unlikely to be disturbed	1	1	0	1	Remove if affected by proposed refurbishment works
				Total	Priority
				3	Low

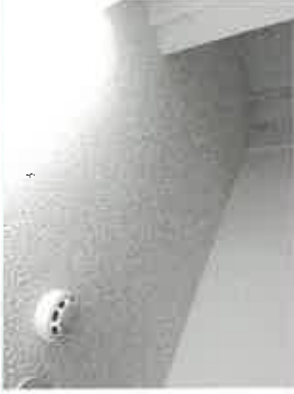
Incident Reference	Sample Number	Level	Material Location	Quantity	Comments
23	EI002184	Ground Floor	Main Building Switchroom and Cupboard 006	6 m ²	
ID	Material Description	Product Type	Asbestos Type		
AD	Textured coating to plasterboard ceiling	Textured Coating	Chrysotile		
Accessibility	Product Type	Extent of Damage	Surface Treatment	Asbestos Type	Recommendation
Usually inaccessible or unlikely to be disturbed	1	1	0	1	Remove if affected by proposed refurbishment works

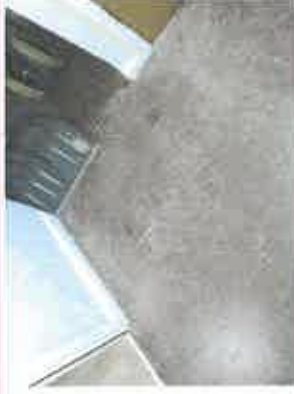
Incident Reference	Sample Number	Level	Material Location	Quantity	Comments
24	EI002185	Ground Floor	Main Building Switchroom and Cupboard 006	6 m ²	
ID	Material Description	Product Type	Asbestos Type		
AD	Brown floor tiles and adhesive to concrete	Vinyl Floor Tiles	Chrysotile		
Accessibility	Product Type	Extent of Damage	Surface Treatment	Asbestos Type	Recommendation
Routinely disturbed	1	2	0	1	Remove if affected by proposed refurbishment works

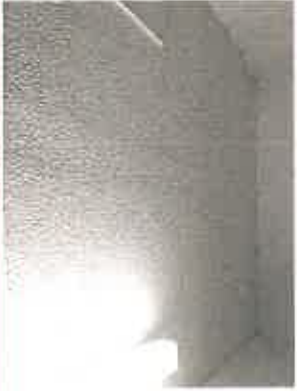
Incident Reference	Sample Number	Level	Material Location	Quantity	Image
25	As EI002184	Ground Floor	Main Building Bin Store 007	10 m ²

ID	Material Description	Product Type	Asbestos Type	Quantity	Comments
SFTCA	Textured coating to plasterboard ceiling	Textured Coating	Chrysotile		
Accessibility	Product Type	Extent of Damage	Surface Treatment	Asbestos Type	Recommendation
Usually inaccessible or unlikely to be disturbed	1	1	0	1	Remove if affected by proposed refurbishment works
				Total	
				3	
				Priority	
				Low

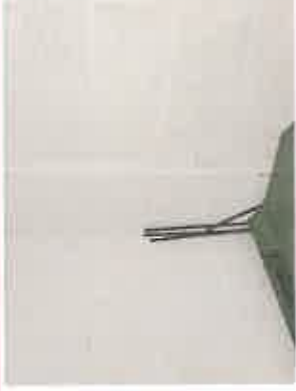
Incident Reference	Sample Number	Level	Material Location	Quantity	Image
26	No sample taken	Ground Floor	Main Building Bin Store 007	Throughout

Main Building /Ground Floor/Bin Store 007 – No access gained within timber boxing due to damage limitations - Presumed chrysotile.

ID	Material Description	Product Type	Asbestos Type	Quantity	Comments
PTCA	No access gained within timber boxing due to damage limitations	N/A	Presumed		
Accessibility	Product Type	Extent of Damage	Surface Treatment	Asbestos Type	Recommendation
N/A	N/A	N/A	N/A	N/A	Exercise Caution

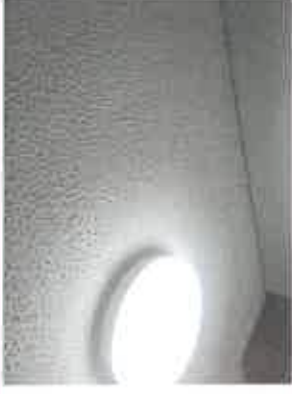
Incident Reference	Sample Number	Level	Material Location	Quantity			
27	EI002186	Ground Floor	Main Building Circulation - Flats 1-8 008	25 m ²			
ID	Material Description	Product Type	Asbestos Type				
AD	Textured coating to plasterboard ceiling	Textured Coating	Chrysotile				
Accessibility	Product Type	Extent of Damage	Surface Treatment	Asbestos Type	Priority	Recommendation	Comments
Usually inaccessible or unlikely to be disturbed	1	1	0	1	3	Low	Remove if affected by proposed refurbishment works

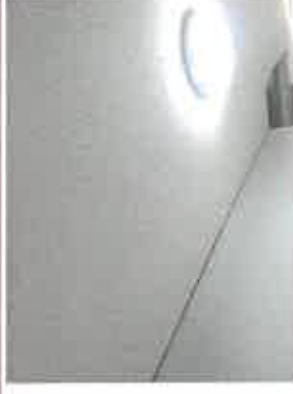
Incident Reference	Sample Number	Level	Material Location	Quantity			
28	EI002187	Ground Floor	Main Building Circulation - Flats 1-8 008	16 m ²			
ID	Material Description	Product Type	Asbestos Type				
AD	Textured coating to plasterboard ceiling	Textured Coating	Chrysotile				
Accessibility	Product Type	Extent of Damage	Surface Treatment	Asbestos Type	Priority	Recommendation	Comments
Usually inaccessible or unlikely to be disturbed	1	1	0	1	3	Low	Remove if affected by proposed refurbishment works

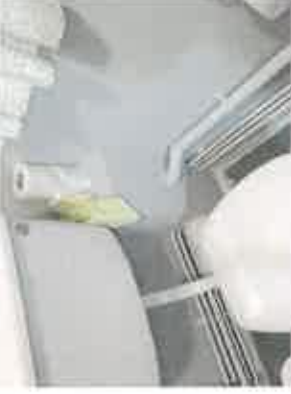
Incident Reference	Sample Number	Level	Material Location	Quantity

Main Building /Ground Floor/WC 010 – No access gained within timber boxing due to damage limitations - Presumed chrysotile.

Comments
32	No sample taken	Ground Floor	Main Building WC 010	Throughout		
ID	Material Description	Product Type	Asbestos Type	Asbestos Type		
PICA	No access gained within timber boxing due to damage limitations	N/A	N/A	Presumed		
Accessibility	Product Type	Extent of Damage	Surface Treatment	Total	Priority	Recommendation
N/A	N/A	N/A	N/A	N/A	N/A	Exercise Caution
						Presumed chrysotile.

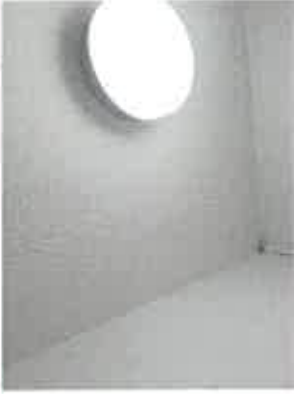
Incident Reference	Sample Number	Level	Material Location	Quantity	
43	As EI002193	Ground Floor	Main Building Phone Cupboard 015	1 m ²

ID	Material Description	Product Type	Asbestos Type		
SPTCA	Textured coating to plasterboard ceiling	Textured Coating	Chrysotile		
Accessibility	Product Type	Extent of Damage	Surface Treatment	Asbestos Type	Recommendation
Usually inaccessible or unlikely to be disturbed	1	1	0	1	Remove if affected by proposed refurbishment works
				Total	Priority
				3	Low

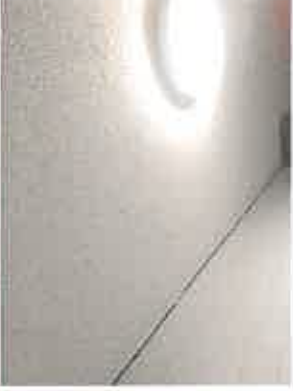
Incident Reference	Sample Number	Level	Material Location	Quantity	Image
46	E002195	Ground Floor	Main Building Circulation - Flats 9-11 & 18-20 017	25 m²

ID	Material Description	Product Type	Asbestos Type	Asbestos Type	
AD	Textured coating to plasterboard ceiling	Textured Coating	Chrysotile	Chrysotile	
Accessibility	Product Type	Extent of Damage	Surface Treatment	Priority	Recommendation
Usually inaccessible or unlikely to be disturbed	1	1	0	3	Low
					Remove if affected by proposed refurbishment works
					Comments

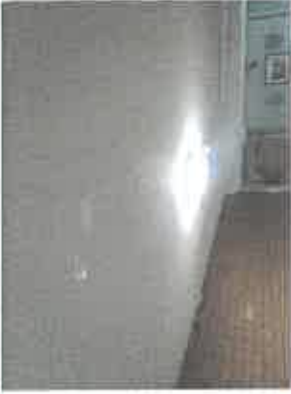
Incident Reference	Sample Number	Level	Material Location	Quantity	
47	EI002196	Ground Floor	Main Building Circulation - Flats 9-11 & 18-20-017	25 m ²

ID	Material Description	Product Type	Asbestos Type		
AD	Textured coating to plasterboard ceiling	Textured Coating	Chrysotile		
Accessibility	Product Type	Extent of Damage	Surface Treatment	Asbestos Type	Priority
Usually inaccessible or unlikely to be disturbed	1	1	0	1	Low
				Total	
				3	
					Recommendation
					Remove if affected by proposed refurbishment works
					Comments

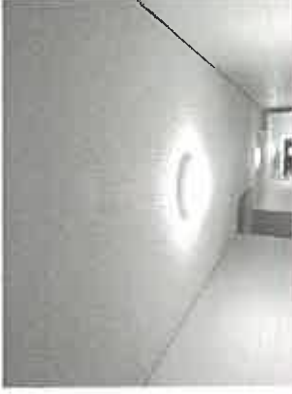
Incident Reference	Sample Number	Level	Material Location	Quantity	
48	EI002197	Ground Floor	Main Building Circulation - Flats 12-17 018	25 m ²

ID	Material Description	Product Type	Asbestos Type		
AD	Textured coating to plasterboard ceiling	Textured Coating	Chrysotile		
Accessibility	Product Type	Extent of Damage	Surface Treatment	Asbestos Type	Priority
Usually inaccessible or unlikely to be disturbed	1	1	0	1	Low
				Total	
				3	
					Recommendation
					Remove if affected by proposed refurbishment works
					Comments

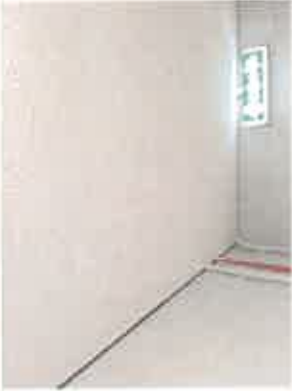
Incident Reference	Sample Number	Level	Material Location	Quantity	
49	EI002198	Ground Floor	Main Building Circulation - Flats 12-17 018	4 m ²

ID	Material Description	Product Type	Asbestos Type	Asbestos Type	
AD	Textured coating to plasterboard ceiling	Textured Coating	Chrysotile	Chrysotile	
Accessibility	Product Type	Extent of Damage	Surface Treatment	Asbestos Type	Priority
Usually inaccessible or unlikely to be disturbed	1	1	0	1	3
Recommendation	Asbestos Type	Priority	Recommendation	Comments	
Remove if affected by proposed refurbishment works	Chrysotile	Low	Remove if affected by proposed refurbishment works

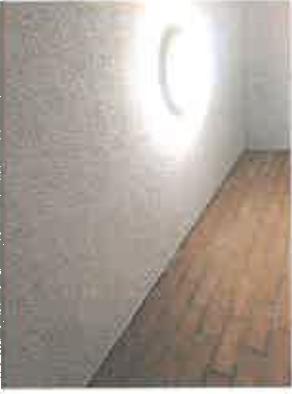
Incident Reference	Sample Number	Level	Material Location	Quantity			
53	E1002200	Ground Floor	Main Building Circulation - Lobby 020	25 m ²

Incident Reference	Location	Material Description	Level of Identification	Asbestos Type	Quantity	Priority	Licensed or Non Licensed Removal	Recommendation
53	Main Building Ground Floor / Circulation - Lobby 020	Textured coating to plasterboard ceiling	AD	Chrysotile	25 m ²	Low	Non-licensed	Remove if affected by proposed refurbishment works
56	Main Building External / External Areas E01	Cement undercloak	AD	Chrysotile	200 lm	Low	Non-licensed	Remove if affected by proposed refurbishment works

ID	Material Description	Product Type	Asbestos Type	Asbestos Type	Comments		
AD	Textured coating to plasterboard ceiling	Textured Coating	Chrysotile				
Accessibility	Product Type	Extent of Damage	Surface Treatment	Asbestos Type	Priority	Recommendation	
Usually inaccessible or unlikely to be disturbed	1	1	0	1	3	Low	Remove if affected by proposed refurbishment works
