Stratford Park Lido, Stroud, Gloucestershire

Condition Survey

**For the attention of:
Stroud District Council**

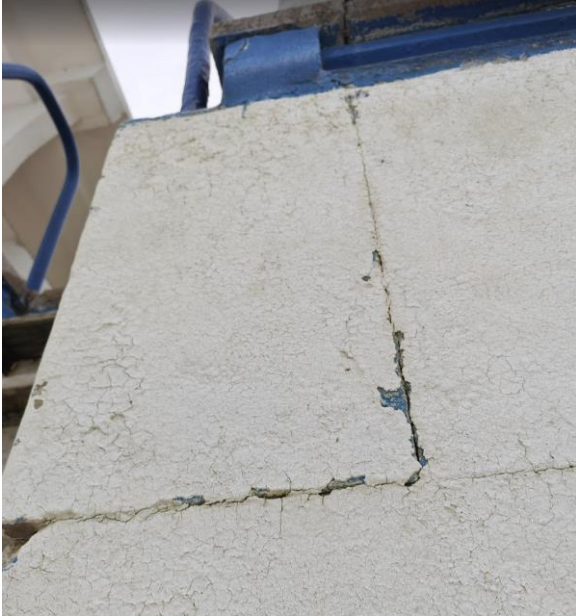
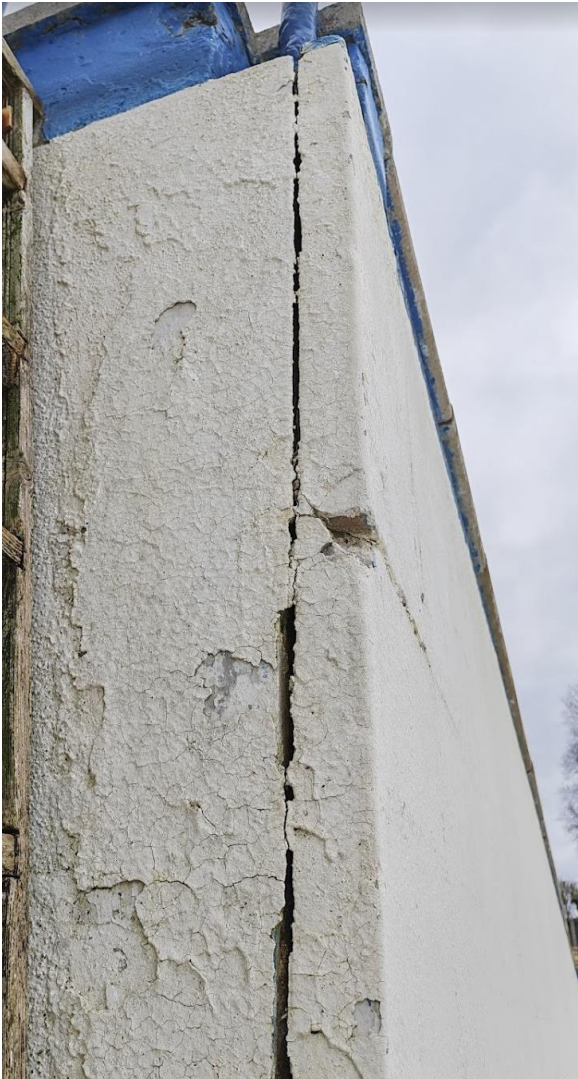
| Findings | | Relevant Law, Guidance, etc. | Recommendations |
|---|---|---|---|
| 1 | <p>The swimming pool walls are what appear to be a concrete block construction applied to the based structure. Evidence shows that this has been coated and painted several times over the years.</p> <p>The blocks show significant signs of movement with large areas of cracks on the joints demonstrating movement. The current integration of the blocks application to the structure is in doubt and certainly the reliability for the block to stay in place is not guaranteed.</p> <p>It is clear that the swimming pool tank is suffering with water loss, causing movement of the structure and the surround poolside paving and coping stones.</p> | <p>BS EN 15288-1 (Swimming Pool Safety Requirements) Part 1: Safety requirements for design</p> <p>HSG 179 Managing Safety in Swimming Pool v4</p> <p>Sport England Design Guidance</p> | <p>Given the evident structural movement within the concrete block wall construction, the extensive cracking along mortar joints, and the uncertainty regarding the continued integrity and adhesion of the blockwork to the primary pool structure, it is recommended that the pool tank is subject to a full structural assessment by a suitably qualified structural engineer.</p> <p>The pattern of cracking and the confirmed water loss indicate ongoing movement of both the tank and the surrounding poolside paving and copings, suggesting that the current construction is no longer performing as a stable retaining structure. Remedial works should therefore prioritise establishing the root cause of water loss, stabilising the tank shell, and determining whether the existing blockwork can be retained or requires full removal and reconstruction.</p> |

Until such investigations and corrective actions are undertaken, the reliability of the wall system cannot be assured, and continued operation of the pool presents a material risk of further deterioration.

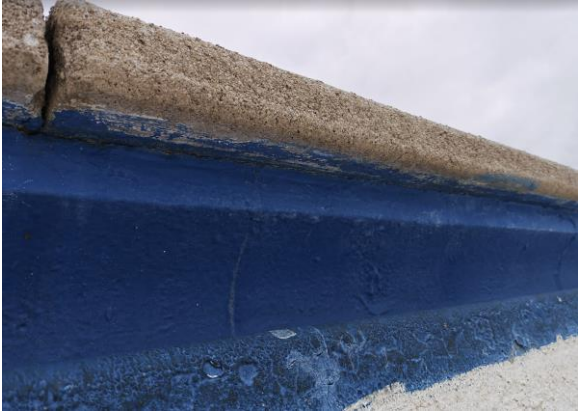
| <p>3.</p> | <p>Surface water collection system is of an older design and flows straight to waste. Traditionally a swimming pool system which is an overflow channel system/scum channel system would remove approximately 10% of the water from the surface for recirculation.</p> <p>The top 30cm of swimming pool water is the dirtiest part of the water. From previous experience of the lido the water level is kept about 15cm below the channels to stop the water removal.</p> | <p>BS EN 15288-1 (Swimming Pool Safety Requirements) Part 1: Safety requirements for design</p> <p>PWTAG Swimming Pool Water 2017</p> | <p>It is recommended that the surface water collection system be fully reviewed and redesigned to meet modern operational standards, as the current arrangement, an older overflow system discharging directly to sewage/waste is inefficient and inconsistent with contemporary pool management practice.</p> <p>A properly functioning scum channel should remove approximately 10% of the surface water for recirculation, ensuring effective removal of contaminants from the upper 30cm of the pool, which is recognised as the dirtiest layer.</p> |

| | <p>Previous visual surveys which I was party to in the previous year confirmed that the system flows straight to the drainage system.</p> | | <p>The historic practice of maintaining the water level approximately 15cm below the channel has prevented the system from operating as intended and may have contributed to water quality and hydraulic inefficiencies.</p> <p>Given that previous visual surveys have confirmed that the existing system drains directly to the sewer, a detailed engineering assessment is required to determine the feasibility of reinstating a compliant overflow and recirculation arrangement, improving water quality, reducing wastage, and ensuring the system aligns with current industry guidance.</p> |

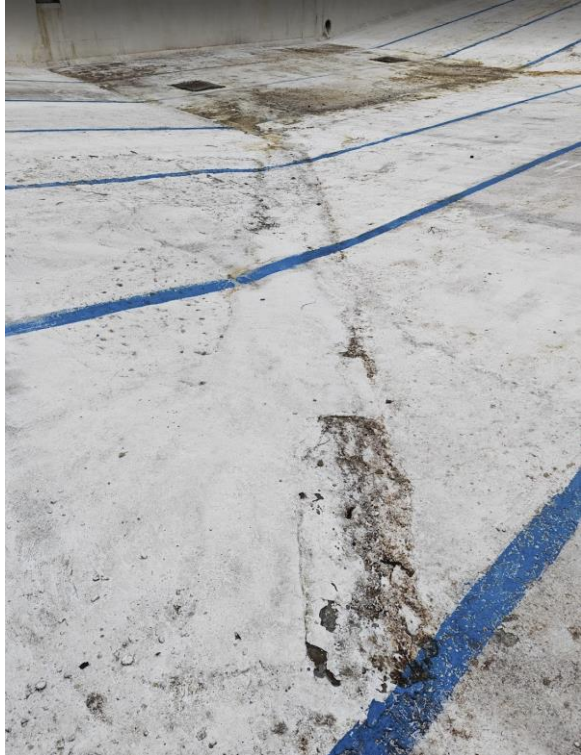
| <p>4.</p> | <p>The swimming pool tank floor is displaying significant damage and evidence of previous repairs. Large sections of base concrete are moving and can be removed by walking and by hand.</p> <p>Damage to the base of the swimming pool will cause two major issues with the swimming pool system.</p> <p>Firstly, again the pool tank floor doesn't appear to be water tight which is the same case as walls.</p> <p>Secondly the loose debris and failing floor structure will cause a loss in turbidity with water clarity.</p> | <p>Managing Health and Safety at Work Regulations 1999 Regulation 3</p> <p>HSG 179 Managing Safety in Swimming Pools v4</p> | <p>The current surface is not in suitable and sufficient condition to be walked on by swimmers in the water. A significant repair to the swimming pool structure is required to the entire pool tank to be in a suitable and sufficient condition.</p> <p>A failed filtration system which results in a loss in water clarity and turbidity from the swimming pool tank debris. This would result in a failed Lifeguard Visibility Zone Test and an inability for the lifeguards to provide constant supervision of the swimming pool.</p> |

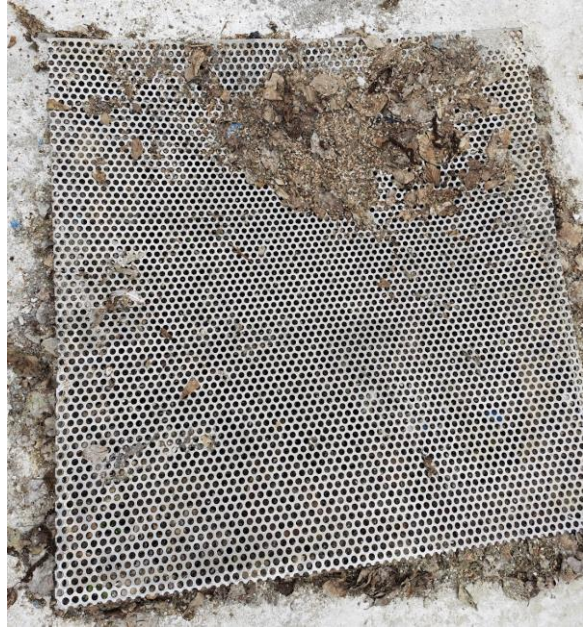
| <p>5.</p> | <p>Outlets covers are flexible and have not been fixed to the swimming pool base. No fixing attachments are on the base of the swimming pool to prevent a swimmer lifting the outlet covers.</p> <p>The apertures are greater than 0.8cm which may put non-employees at risk of finger entrapment.</p> | <p>Managing Health and Safety at Work Regulations 1999 Regulation 3</p> <p>BS EN 13451</p> | <p>It is recommended that new outlets are installed in accordance with current design expectations, ensuring that a minimum of two outlets are provided to achieve safe and effective hydraulic performance.</p> <p>These outlets should be manufactured from a durable and corrosion-resistant material, such as 316-grade stainless steel, to ensure long-term reliability in a chlorinated aquatic environment.</p> |

| | | | <p>As part of the manufacturing process, the outlet apertures must be designed to ensure that no opening exceeds 0.8cm, in line with recognised safety requirements to prevent entrapment and ensure safe operation. These upgrades will improve system performance, enhance user safety, and bring the installation into alignment with modern standards.</p> |

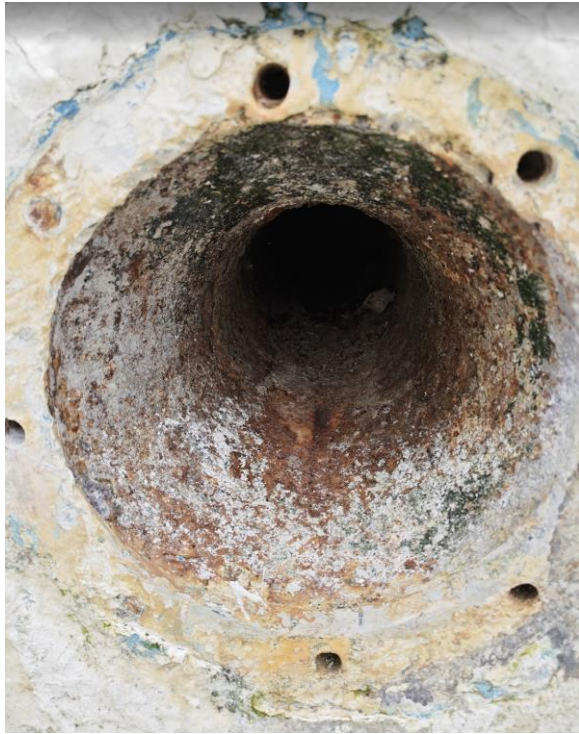
| <p>6.</p> | <p>Deep end inlet/outlet has no cover which can cause leg or arm entrapment to the swimmer. Additionally, the fixings are heavily corroded.</p> <p>At this stage the outcome of this inlet/outlet pictured below is unknown and may be a drainage point for winter periods.</p> | <p>Managing Health and Safety at Work Regulations 1999 Regulation 3</p> <p>BS EN 13451</p> | <p>New inlet/outlet are required. New inlet/outlet to be manufactured using suitable material such as stainless steel 316. New apertures to be part of the manufacture to ensure no greater than 0.8cm.</p> |

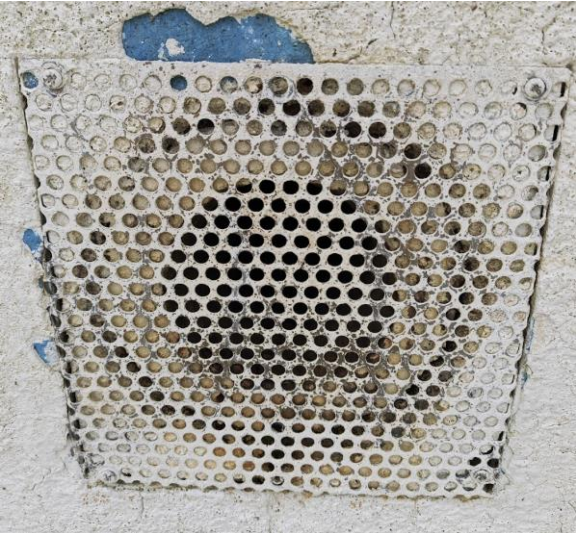
7. Although inlet covers appear to be fixed to the walls, there are several sharp edges along the sides of the covers. The design appears to be a retro fit on to the swimming pool tank walls.

New inlet covers are required to be manufactured in suitable material such as stainless steel 316. New integral apertures should not exceed 8mm.

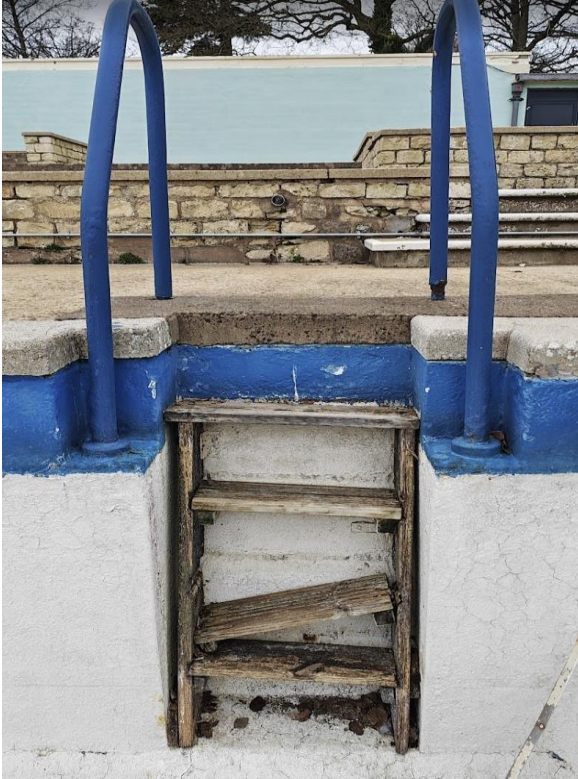
| <p>8.</p> | <p>The swimming pool step ladders are constructed from timber decking boards, which is not an acceptable material for this type of installation and does not comply with the relevant British Standards for swimming pool access equipment.</p> <p>Purpose-designed pool ladders must be manufactured from corrosion-resistant materials, incorporate compliant handrails, and meet defined dimensional and load-bearing requirements to ensure safe ingress and egress for users.</p> <p>The structural integrity of the existing timber steps can be verified as inadequate this has been caused by inappropriate materials and construction deterioration has been accelerated</p> | <p>Managing Health and Safety at Work Regulations 1999 Regulation 3</p> <p>BS EN 13451</p> | <p>It is recommended that the existing timber step ladders be removed from service without delay, as they do not comply with the relevant British Standards for swimming pool access equipment and their structural integrity and load cannot be verified.</p> <p>A compliant replacement ladder system, constructed from suitable corrosion-resistant materials and designed specifically for swimming pool use, should be installed to ensure safe ingress and egress for all users.</p> <p>A full inspection of the fixing points and surrounding pool wall should also be undertaken once the timber structure is removed, to confirm that no hidden</p> |

| | <p>by water exposure and potential biological growth and they are now at the point of failure.</p> <p>I am unable to confirm their load capacity, or the extent of any hidden decay or weakening of the fixings or supporting structure. This presents a foreseeable and significant safety risk to users.</p> | | <p>deterioration has occurred. These actions are necessary to eliminate the foreseeable risk of failure and to restore the installation to an acceptable safety standard.</p> |

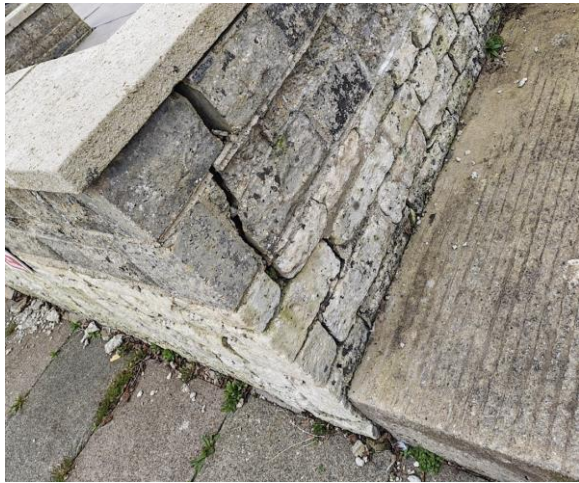
| <p>12.</p> | <p>Several areas of the site contain low walls with unprotected edges, exposing individuals to a foreseeable risk of falling from height. There are no protective barriers, guarding, or physical controls in place, and verbal accounts indicate that falls from these edges have occurred previously.</p> <p>Movement of the walls is also present with large cracks through the stone work as illustrated below.</p> <p>In addition, the coping stones along the tops of these walls are loose and can be displaced either by foot pressure or by hand, further increasing the likelihood of an incident. The</p> | <p>Health and Safety at Work Act 1974</p> <p>Management of Health and Safety at Work Regulations 1999 Regulation 3</p> <p>Working at Heights Regulations 2005</p> | <p>It is recommended that immediate protective measures are implemented to prevent access to the unprotected wall edges, given the foreseeable risk of falls and the evidence of previous incidents.</p> <p>The loose coping stones should be secured or removed without delay to eliminate the risk of displacement under foot or hand pressure. A full assessment of the wall structures should then be undertaken to determine the extent of deterioration and to identify appropriate long-term remedial works.</p> <p>These actions are necessary to ensure the safety of all individuals on site and to bring the</p> |

combination of unprotected drops and unstable coping stones presents a significant and immediate safety hazard to all users of the site, requiring prompt remedial action.

area back into compliance with relevant health and safety requirements.

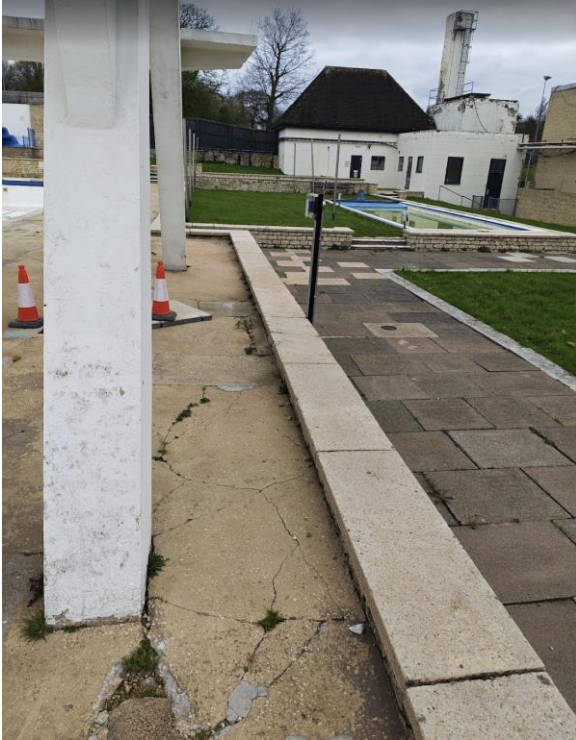
13. The diving board structure itself appears to be in generally good order, with no immediate defects observed on the platform or supporting frame.

However, there are significant structural cracks present within the concrete and paving that surround the diving board installation. These defects indicate localised deterioration of the surrounding slab and may compromise the stability of the adjacent surfaces. As highlighted previously, the cracked pool wall blocks shown

| | <p>in Section 1 are located immediately adjacent to the steps leading to the diving platform.</p> <p>This proximity suggests a plausible pathway for water to migrate from the pool tank into the surrounding ground. Such water egress can soften the supporting soils, reduce bearing capacity, and contribute to the ground movement now evident around the diving board area.</p> <p>The combined presence of structural cracking and potential water infiltration warrants further investigation to determine the extent of deterioration and the associated risks to users.</p> | | <p>taken to restrict access to the affected area until the stability of the surrounding surfaces is confirmed.</p> <p>Following the results of these investigations, appropriate remedial works should be implemented to restore structural integrity, prevent further water migration, and ensure the long-term safety of users.</p> |

It is recommended that a detailed structural assessment is undertaken of the diving board surrounds to determine the extent of cracking and any associated deterioration of the supporting slabs.

Given the proximity of previously identified damaged pool wall blocks and the likelihood of water egress contributing to ground movement, a targeted investigation into potential leakage pathways should also be carried out. Immediate measures should be

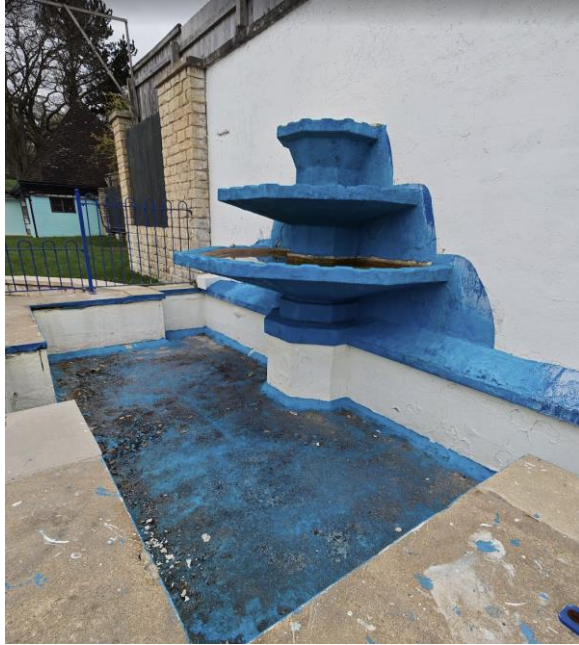
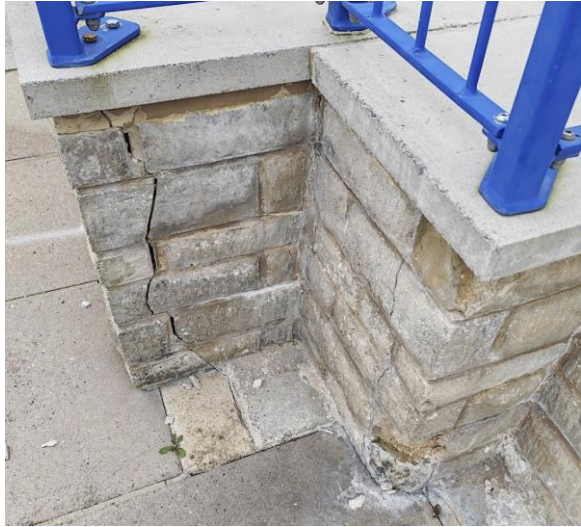
| 14. | <p>Aeration of water was key in the building of swimming pools in the past.</p> <p>The reasons are clear, as when oxygen is added to water, it enhances the treatment of disinfection and stability of pH control by the chemical process of adding the dissolved oxygen as part of the circulation system. Also, it enhances the clarity of pool water through oxygenation.</p> <p>Until the late 1960`s, most pools ran with slow rate filtration which meant that turnover times of 4 to 8 hours plus were commonplace. This meant that the disinfection process of adding chlorine to the water was inhibited as to contact time, with the pollution of the water by the atmosphere (in outdoor pools) and the bathers who traditionally did not shower before bathing.</p> | | <p>The fountain aerator is an important component of the original system and should be retained as a historical feature of the site. Its preservation will help maintain the heritage value and operational narrative of the facility.</p> <p>However, the associated pipework serving the aerator, along with the structural elements of the fountain area itself, are in a severely deteriorated condition and require urgent repair.</p> <p>The pipework shows signs of significant ageing and potential failure, while the surrounding concrete and structural surfaces exhibit extensive cracking, spalling, and general degradation.</p> <p>Without intervention, these defects will continue to worsen, potentially compromising</p> |

both the functionality of the aerator and the safety of individuals accessing the area.

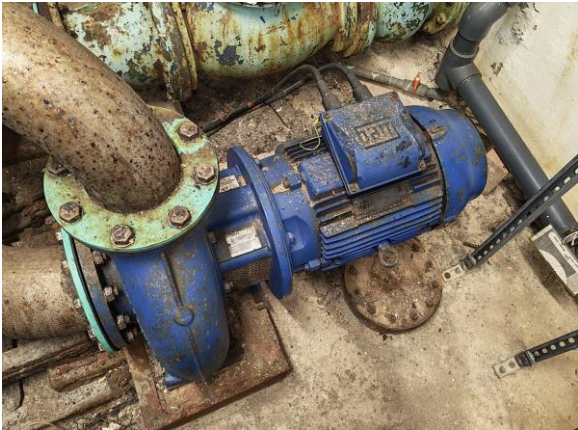
| <p>15.</p> | <p>The circulation pump appears to be in reasonable visual condition; however, it is difficult to reliably assess its operational performance given that the system has not run since last season.</p> <p>When pumps remain idle for extended periods, there is a significant risk of bearing seizure, internal corrosion, and mechanical stiffening, all of which may only become evident once the pump is placed under load.</p> <p>Furthermore, the installation relies on a single-pump configuration, which is no longer considered a viable or resilient method for ensuring continuous circulation throughout the swimming season.</p> | <p>Provision and Use of Work Equipment Regulations 1992</p> <p>PWTAG Swimming Pool Water 2017</p> | <p>It is recommended that the circulation pump be fully serviced and tested prior to the start, with particular attention given to the condition of the bearings and internal components, as prolonged inactivity increases the likelihood of seizure or mechanical failure.</p> <p>Given that the system currently relies on a single pump, a duty-and-standby arrangement should be introduced to provide operational resilience, maintain continuous circulation, and ensure compliance with modern expectations for reliability and water quality management.</p> <p>The installation of a secondary pump will reduce the risk of unplanned downtime and</p> |

| | <p>Modern operational standards typically require duty-and-standby arrangements to maintain water quality, provide redundancy in the event of pump failure, and ensure uninterrupted operation. The current setup therefore presents both reliability and compliance concerns that should be addressed as part of the wider system refurbishment.</p> | | <p>help ensure that the pool can operate safely and consistently throughout the season.</p> |

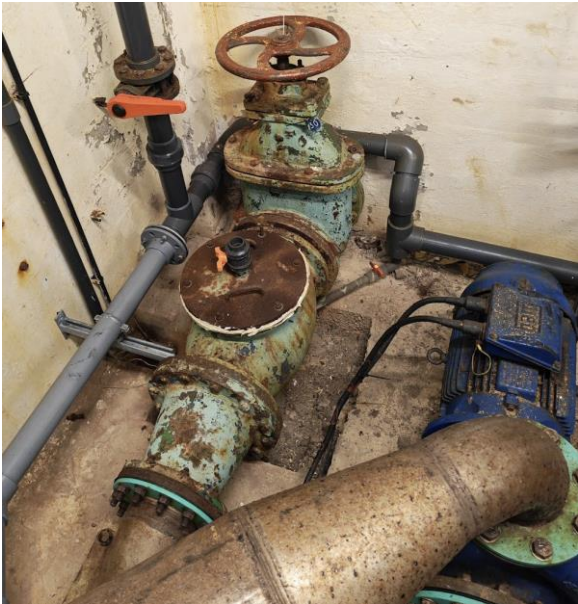
| <p>16.</p> | <p>The swimming pool strainer is not accessible, as the strainer lid has been permanently sealed to the housing using silicone. This prevents routine opening of the strainer basket, meaning physical debris cannot be removed before it reaches the circulation pump impellor.</p> <p>Without the ability to carry out this essential maintenance task, the system is unable to operate safely or efficiently. Accumulated debris within the strainer would progressively reduce flow rates, impairing circulation and filtration</p> | <p>Provision and Use of Work Equipment Regulations 1992</p> <p>PWTAG Swimming Pool Water 2017</p> | <p>It is recommended that the existing strainer assembly be removed and replaced with a properly designed, fully accessible unit that allows routine opening and cleaning of the strainer basket.</p> <p>The current arrangement where the lid has been sealed to the housing with silicone prevents essential maintenance and creates a foreseeable risk of reduced flow, pump damage, and system blockages.</p> |

| <p>performance, and increasing the risk of pump cavitation.</p> <p>Cavitation is the rapid formation and violent collapse of vapor bubbles within a liquid, occurring when local static pressure drops below the liquid's vapor pressure. Often found in hydraulic machinery like pumps and propellers, this phenomenon causes bubbles to implode near hard surfaces, creating high-energy shock waves that cause erosion, noise, reduced efficiency, and potential mechanical failure.</p> <p>More critically, an obstructed strainer can allow debris to pass further into the system, leading to blockages within the pipework. Such blockages can generate excessive pressure differentials, which in turn may cause fractures or failures in the system's pipework and fittings.</p> <p>The current arrangement therefore presents a foreseeable and preventable risk of mechanical damage and operational failure.</p> | | <p>A compliant strainer with a secure but serviceable lid should be installed to ensure that debris can be removed before reaching the impellor, thereby maintaining hydraulic performance and preventing pressure build-up within the pipework.</p> <p>Once replaced, the system should be pressure-tested to confirm that no damage has occurred as a result of previous blockages or restricted flow. These actions are necessary to restore safe operation and protect the wider circulation system from avoidable mechanical failure.</p> |

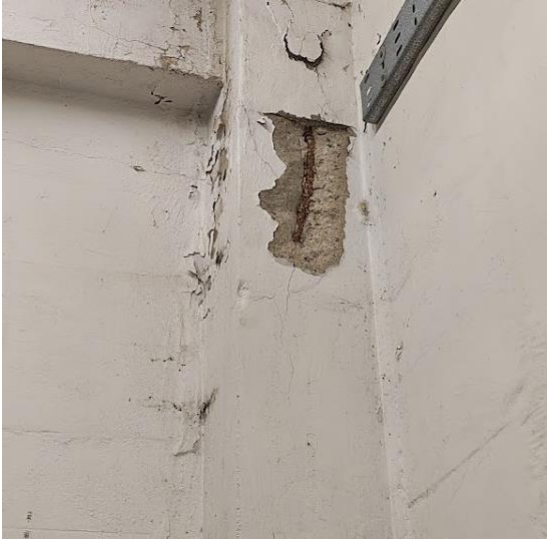
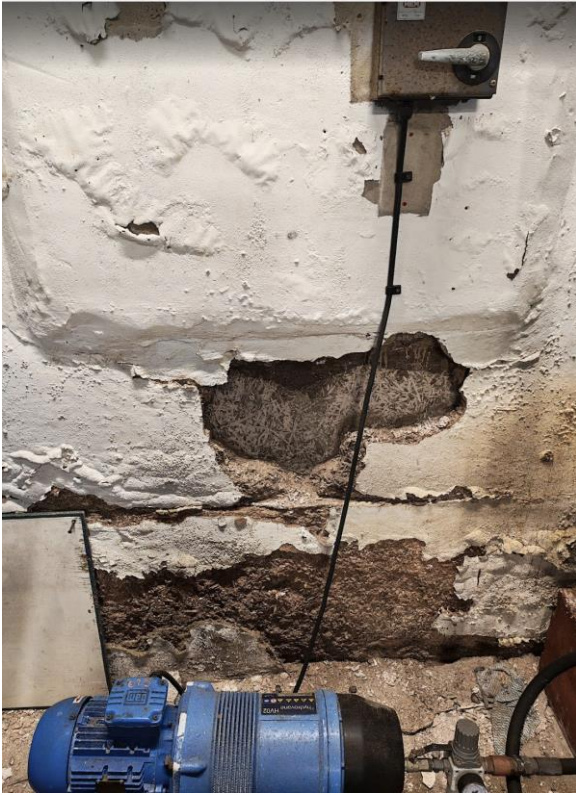
| <p>21.</p> | <p>The pool plant building underwent a structural assessment last year, during which several areas of failed concrete were identified. These defects indicate progressive deterioration of the building fabric and suggest that the reinforced concrete elements have been exposed to moisture ingress and environmental degradation over an extended period. In addition to the concrete failures, there is clear evidence of water damage affecting the surrounding brickwork, including staining, spalling, and mortar deterioration.</p> <p>Such damage is consistent with long-term moisture penetration and may indicate compromised waterproofing, defective drainage, or leaks originating from the plant installation itself. The combined deterioration of both concrete and brickwork raises concerns regarding the ongoing structural integrity and environmental suitability of the building for housing sensitive mechanical and electrical plant.</p> | <p>Health and Safety at Work Act 1974</p> | <p>Areas of spalled, delaminated, or weakened concrete should be broken out, treated, and reinstated using appropriate repair mortars in accordance with recognised structural repair standards.</p> <p>The brickwork showing signs of water damage should also be assessed for compromised mortar joints, saturation, and potential loss of load-bearing capacity, with remedial works implemented as required. In parallel, the source of water ingress must be identified and rectified whether arising from defective waterproofing, inadequate drainage, or leaks associated with the plant installation to prevent further deterioration.</p> <p>These actions are essential to restore the structural integrity of the building and ensure it remains suitable for housing mechanical and electrical plant.</p> |
