ASBESTOS REFURBISHMENT SURVEY REPORT

**St Nicholas Court Opu
Elmgrove Estate
Hardwicke
Gloucester
Gloucestershire
GL2 4XW**

4th January 2024

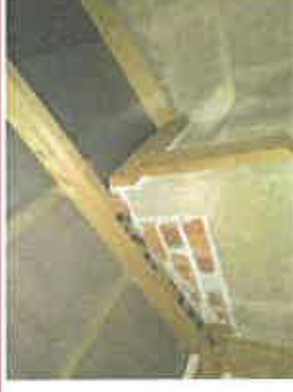
Incident Reference	Sample Number	Level	Material Location	Quantity	Comments
1	EI002168	Roof Void	Main Building Roof Void - Circulation Flats 1-8 A01	25 lm	
ID	Material Description	Product Type	Asbestos Type	Asbestos Type	Comments
NAD	Insulating board firebreaks behind timber beams	N/A	N/A	No Asbestos Detected	
Accessibility	Product Type	Extent of Damage	Surface Treatment	Priority	Recommendation
N/A	N/A	N/A	N/A	N/A	No Action

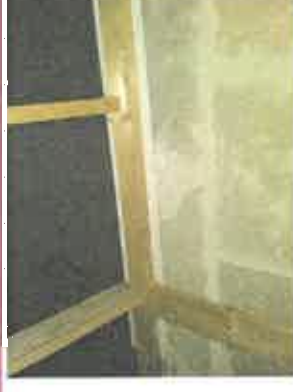
Incident Reference	Sample Number	Level	Material Location	Quantity	Comments
2	EI002169	Roof Void	Main Building Roof Void - Circulation Flats 1-8 A01	20 lm	
ID	Material Description	Product Type	Asbestos Type	Asbestos Type	Comments
NAD	Insulating board firebreaks behind timber beams	N/A	N/A	No Asbestos Detected	
Accessibility	Product Type	Extent of Damage	Surface Treatment	Priority	Recommendation
N/A	N/A	N/A	N/A	N/A	No Action

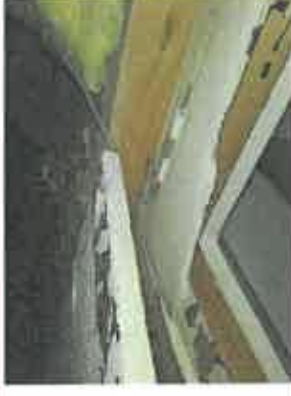
Incident Reference	Sample Number	Level	Material Location	Quantity	Comments
4	EI002171	Roof Void	Main Building Roof Void - Laundry A03	<2 m ²	
ID	Material Description	Product Type	Asbestos Type	Asbestos Type	
N/A	Insulating board debris to loft hatch and to floor of roof void	N/A	N/A	No Asbestos Detected	
Accessibility	Product Type	Extent of Damage	Surface Treatment	Total	Priority
N/A	N/A	N/A	N/A	N/A	N/A

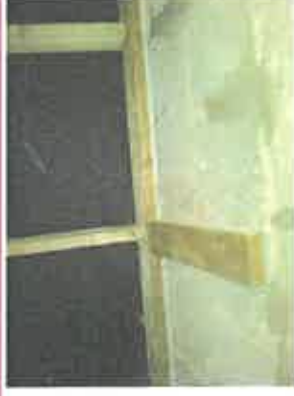
Incident Reference	Sample Number	Level	Material Location	Quantity	Comments	
12	EI002177	Roof Void	Main Building Roof Void - Circulation Flats 27-35 A09	25 lm		
ID	Material Description	Product Type	Asbestos Type	Asbestos Type	Comments	
NAD	Insulating board firebreaks behind timber beams	N/A	N/A	No Asbestos Detected		
Accessibility	Product Type	Extent of Damage	Surface Treatment	Total	Priority	Recommendation
N/A	N/A	N/A	N/A	N/A	N/A	No Action

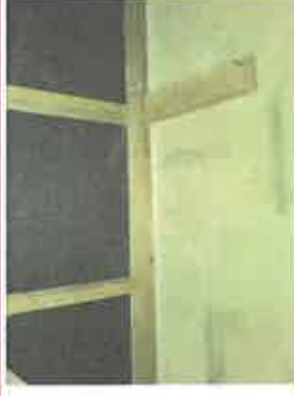
Incident Reference	Sample Number	Level	Material Location	Quantity	Comments	
13	EI002178	Roof Void	Main Building Roof Void - Circulation Flats 27-35 A09	25 lm		
ID	Material Description	Product Type	Asbestos Type	Asbestos Type	Comments	
NAD	Insulating board firebreaks behind timber beams	N/A	N/A	No Asbestos Detected		
Accessibility	Product Type	Extent of Damage	Surface Treatment	Total	Priority	Recommendation
N/A	N/A	N/A	N/A	N/A	N/A	No Action

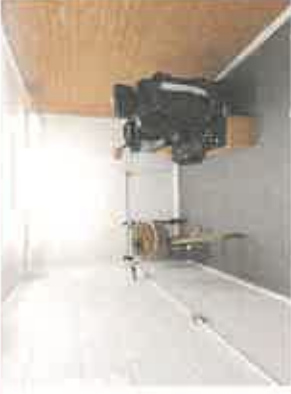
Incident Reference	Sample Number	Level	Material Location	Quantity	Comments	
16	No sample taken	Ground Floor	Main Building Scooter Room 002	Throughout

ID	Material Description	Product Type	Asbestos Type	Asbestos Type		
MAD	Area inspected. No ACMs identified or presumed within the scope of the survey	N/A		No Asbestos Detected		
Accessibility	Product Type	Extent of Damage	Surface Treatment	Total	Priority	Recommendation
N/A	N/A	N/A	N/A	N/A	N/A	No Action

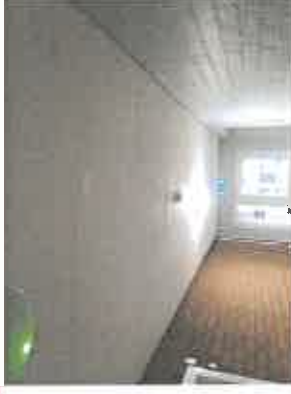
Incident Reference	Sample Number	Level	Material Location	Quantity	Comments	
18	EI002181	Ground Floor	Main Building Circulation - Flats 23-27 003	25 m²

ID	Material Description	Product Type	Asbestos Type	Asbestos Type		
MAD	Insulating board ceiling panels	N/A		No Asbestos Detected		
Accessibility	Product Type	Extent of Damage	Surface Treatment	Total	Priority	Recommendation
N/A	N/A	N/A	N/A	N/A	N/A	No Action

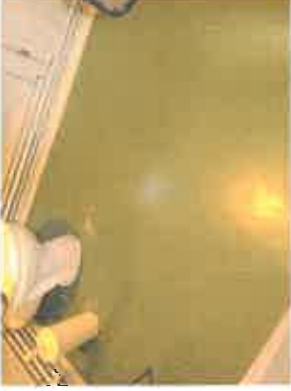
Incident Reference	Sample Number	Level	Material Location	Quantity	Comments
31	EI002188	Ground Floor	Main Building WC 010	4 m ²	
ID	Material Description	Extent of Damage	Surface Treatment	Product Type	Asbestos Type
NAD	Green vinyl floor tiles to concrete	N/A	N/A	N/A	No Asbestos Detected
Accessibility	Product Type	Priority	Total	Recommendation	
N/A	N/A	N/A	N/A	No Action

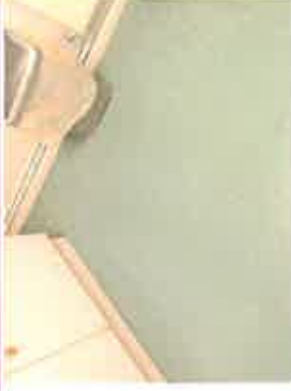
Incident Reference	Sample Number	Level	Material Location	Quantity	Comments
38	As EI002188	Ground Floor	Main Building Kitchen 012	6 m ²	
ID	Material Description	Extent of Damage	Surface Treatment	Product Type	Asbestos Type
NAD	Green floor tiles to concrete	N/A	N/A	N/A	No Asbestos Detected
Accessibility	Product Type	Priority	Total	Recommendation	
N/A	N/A	N/A	N/A	No Action

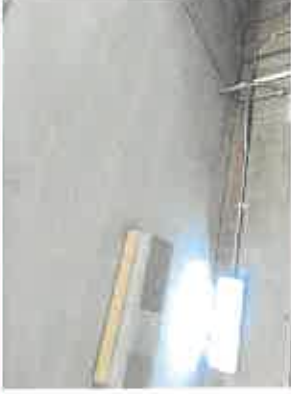
Incident Reference	Sample Number	Level	Material Location	Quantity	Comments
40	EI002192	Ground Floor	Main Building Boiler Room 013	10 m ²	
ID	Material Description	Product Type	Asbestos Type	Asbestos Type	Recommendation
NAD	Insulating board ceiling panels	N/A	N/A	No Asbestos Detected	
Accessibility	Product Type	Extent of Damage	Surface Treatment	Priority	Recommendation
N/A	N/A	N/A	N/A	N/A

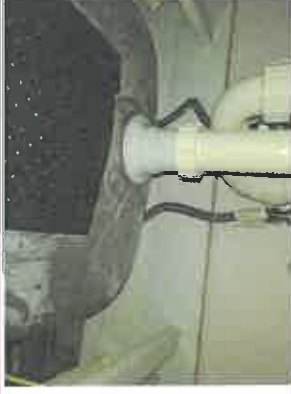
Incident Reference	Sample Number	Level	Material Location	Quantity	Comments
42	EI002194	Ground Floor	Main Building Laundry Room and Cupboard 014	1 no.	
ID	Material Description	Product Type	Asbestos Type	Asbestos Type	Recommendation
NAD	Sink pad	N/A	N/A	No Asbestos Detected	
Accessibility	Product Type	Extent of Damage	Surface Treatment	Priority	Recommendation
N/A	N/A	N/A	N/A	N/A

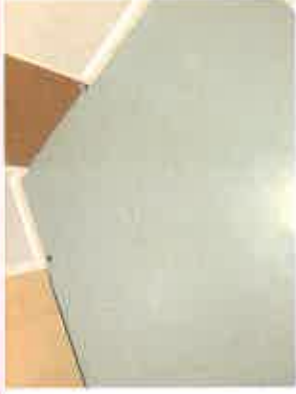
Incident Reference	Sample Number	Level	Material Location	Quantity	Comments
54	As E1002188	Ground Floor	Main Building Circulation - Lobby 020	4 m ²	
ID	Material Description	Product Type	Asbestos Type	Asbestos Type	Asbestos Type
NAD	Green floor tiles to screed to concrete	N/A	N/A	No Asbestos Detected	
Accessibility	Product Type	Extent of Damage	Surface Treatment	Total	Priority
N/A	N/A	N/A	N/A	N/A	N/A
					No Action

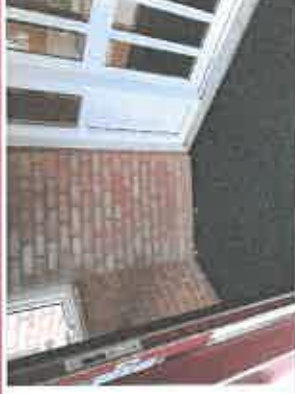
Incident Reference	Sample Number	Level	Material Location	Quantity	Comments
55	No sample taken	Ground Floor	Main Building Entrance Lobby 021	Throughout	
ID	Material Description	Product Type	Asbestos Type	Asbestos Type	Asbestos Type
NAD	Area inspected. No ACMs identified or presumed within the scope of the survey	N/A	N/A	No Asbestos Detected	
Accessibility	Product Type	Extent of Damage	Surface Treatment	Total	Priority
N/A	N/A	N/A	N/A	N/A	N/A
					No Action

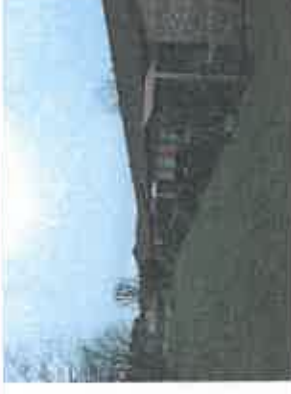
Incident Reference	Sample Number	Level	Material Location	Quantity	Comments	
58	EI002203	External	Main Building External Areas E01	25 lm

ID	Material Description	Product Type	Asbestos Type	Asbestos Type		
N/A	Insulating board soffits	N/A	N/A	No Asbestos Detected		
Accessibility	Product Type	Extent of Damage	Surface Treatment	Total	Priority	Recommendation
N/A	N/A	N/A	N/A	N/A	N/A	No Action

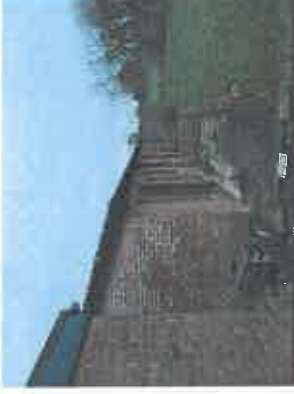
Incident Reference	Sample Number	Level	Material Location	Quantity	Comments
69	EI002214	External	Main Building External Areas E01	25 lm	
ID	Material Description	Product Type	Asbestos Type	Asbestos Type	Recommendation
NAD	Insulating board soffits	N/A	N/A	No Asbestos Detected	
Accessibility	Product Type	Extent of Damage	Surface Treatment	Priority	Recommendation
N/A	N/A	N/A	N/A	N/A

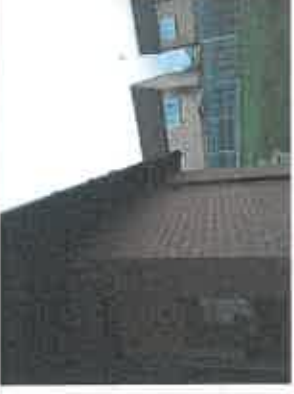
Incident Reference	Sample Number	Level	Material Location	Quantity	Comments
70	EI002215	External	Main Building External Areas E01	17 lm	
ID	Material Description	Product Type	Asbestos Type	Asbestos Type	Recommendation
NAD	Insulating board soffits	N/A	N/A	No Asbestos Detected	
Accessibility	Product Type	Extent of Damage	Surface Treatment	Priority	Recommendation
N/A	N/A	N/A	N/A	N/A
