CASE STUDY

Snows Farm Nature Reserve

**STROUD RURAL
SUSTAINABLE
DRAINAGE PROJECT**

NATURAL FLOOD MANAGEMENT
IN THE STROUD VALLEYS

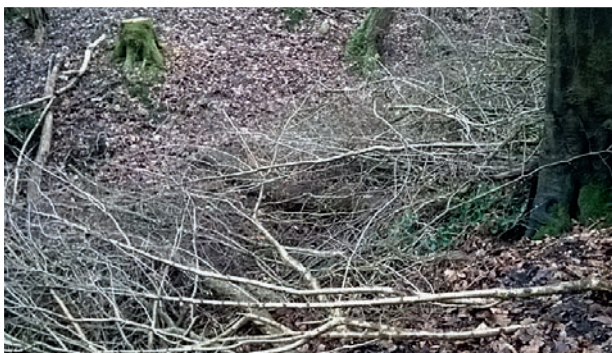
The aim of the project was to slow down the flow of flood peaks into the valley and divert water onto small floodplains. Fifteen leaky dams constructed from tree trunks and branches were installed to create a partial blockage of the stream. In low flows, water can pass freely under the structures but, at high flows after very heavy rain, some water will be attenuated behind the leaky dam.

The stream-side woodland is mostly alder, ash and hazel coppice. This has been unmanaged for approximately 30 years so a considerable amount of coppicing and clearing was required before workers could fell the larger trees that were needed for the leaky dams. The banks are too steep for machine access so all of the work was carried out by a two-man felling team. Felled trees were manipulated into place using a Tirfor winch. All of the tree trunks were then pinned in place using 1.2m reinforcing steel bars, through holes drilled with a petrol auger, to clamp the material together and secure the structures into the ground. The timber was donated to the project by the landowner.
